RIVER AND WATER MANAGEMENT IN THE FENLAND

The Fenland is a landscape that reflects the interplay between environmental and social processes over centuries. This field excursion will examine the initial formation of the Fenland region, the draining of the Fens, and contemporary water management in the Fens, and will provide a useful background for the session on multi-purpose water management tomorrow, in which we consider institutional partnerships at the local scale.

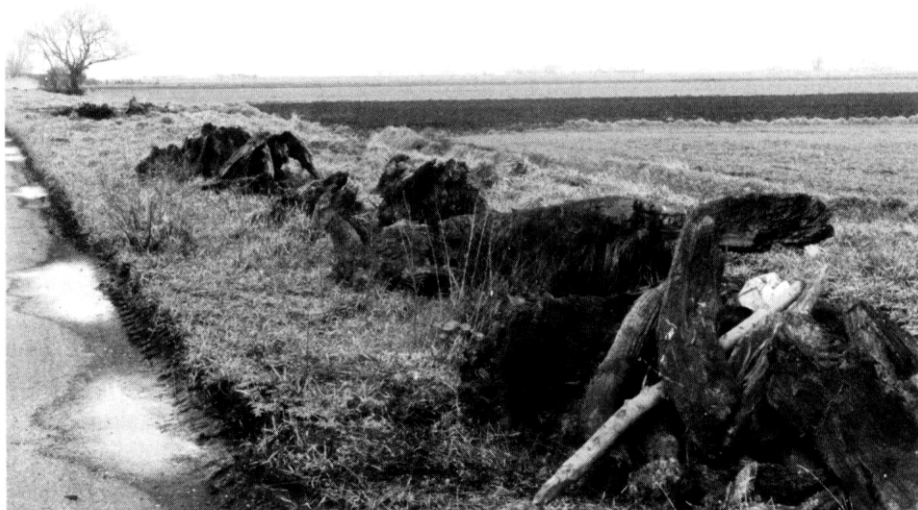
Figure A

Fig. 28 'Bog oaks' along the roadside near Aldreth, April 1977. Photo: M. J. Petty. These fossil remains include a variety of species, as may be seen from Fig. 27 above, but they are all generally called 'bog oak'. See H. Godwin, *Fenland: its ancient past and uncertain future* (Cambridge, 1978) 32-42.

In the Flandrian, or Holocene, the history of the Fenland region has been dominated by an alternation between marine and terrestrial (freshwater) conditions as the relative elevation of the sea has varied. These changes arose from the interaction of post-glacial eustatic sea level rise, the effects of isostasy in southern Britain, and local tectonic influences. Initially, from about 10,000 to 6,000 BP, the sea-level rose continuously and the North Sea expanded. A rapid transgression of the sea into the lower reaches of the valley of the proto-Nene and Great Ouse created the Wash, and the gently-sloping valley above this became well-wooded after 6,000 BP, and had a poorly-drained, damp environment with freshwater fens and meres. This landscape was dominated by the development of extensive freshwater peats because of the poor drainage, which reached thicknesses of about 0.5-1.5 m. Trees - especially bog oaks - grew in this peat, and where the peat is at the present-day surface, the trunks of these have been revealed by ploughing (Figure A).

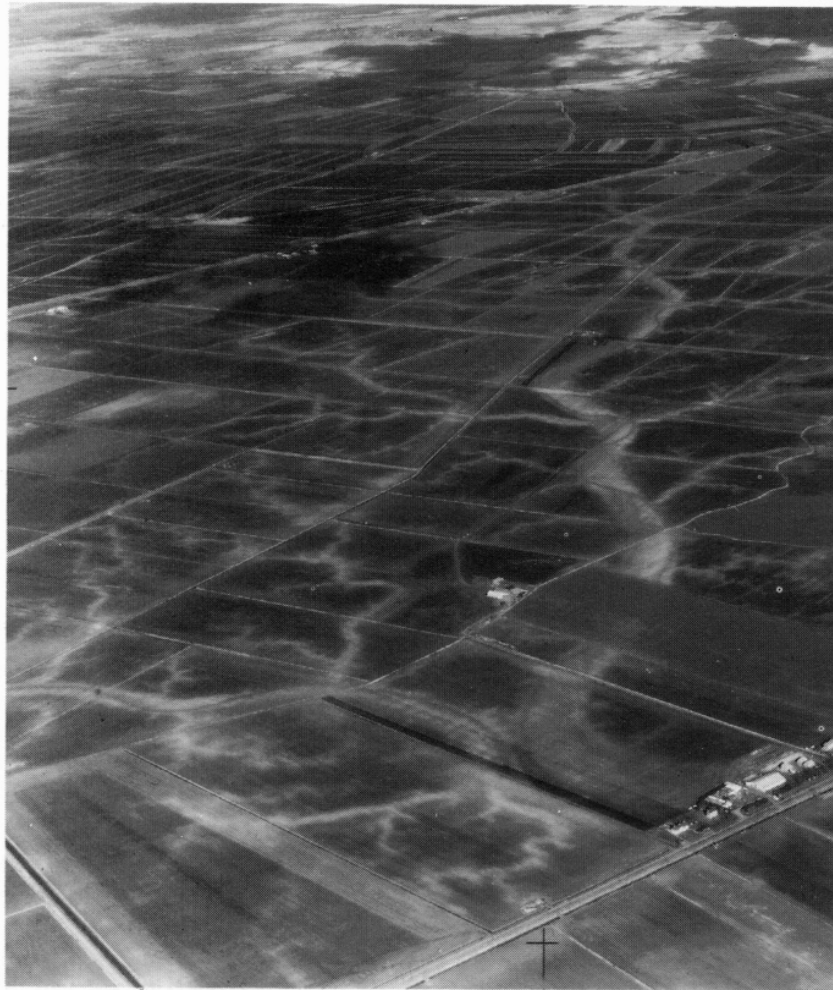
Figure Cb

Plate 9a Wastage of the Nordelph Peat has revealed a complex pattern of silt-filled tidal creeks within the underlying Barroway Drove Beds. As the peat continues to waste and the Barroway Drove Beds clays that enclose the silts consolidate, the silts are beginning to form low-relief roddons. View E across Methwold Fens from near Brandon Creek (Cambridge University Air Photo Library, AXI 46)

When the Fens had been drained, the silty Holocene deposits consolidated, and the peat dried out and shrank. It then became very susceptible to wind-blow, and there was very rapid wastage. In some places, the younger peat at the surface disappeared and the underlying Barroway Drove Beds (silts) were exposed. The shrinkage of the peat is also why the silty roddons appear as lighter-coloured ridges meandering through the Fens (Figure Cb); they are often the best locations for buildings because the foundations are more solid.

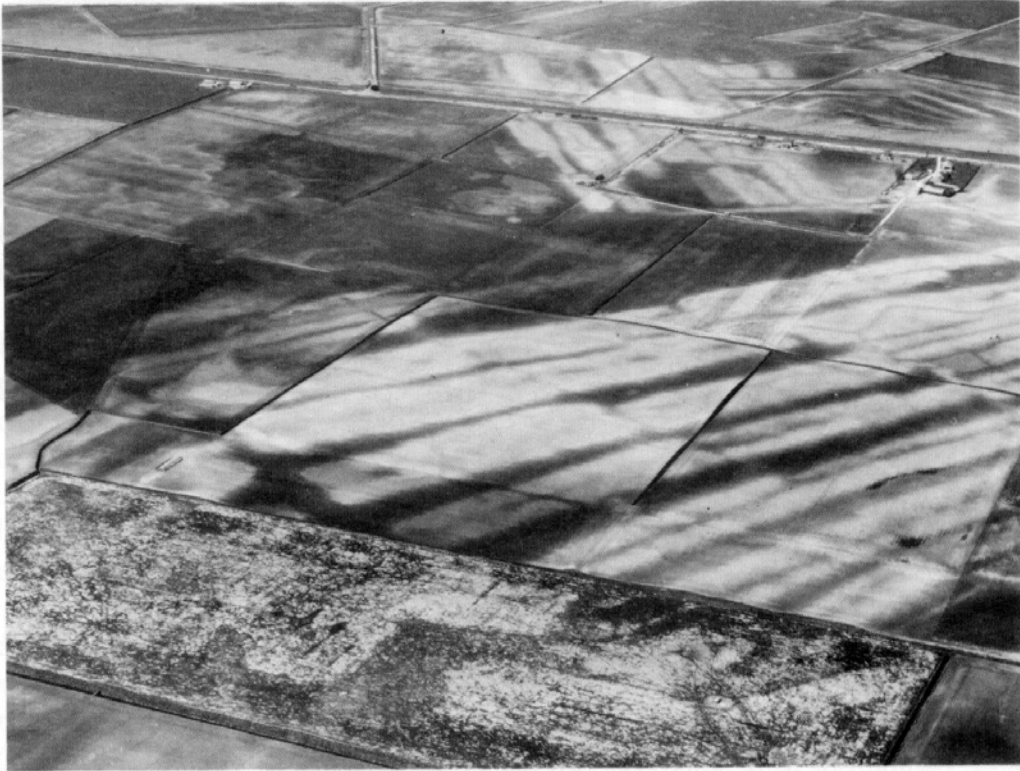
Figure E

Fig. 21 Evidence for medieval turbaries in Upwell Fen (476951) Norfolk, looking north-west (April 1955).

Photo: Cambridge University Collection. The straight line across the background is the Sixteen Foot Drain made in 1651. The narrow black bands represent balks of uncut peat between medieval turbaries filled with light-coloured river silt. This silt now stands about 4 feet higher than the black peat around. The former level of the peat surface before wastage was some 10 to 12 feet above that of the present day. See M. W. Beresford and J. K. S. St Joseph, *Medieval England: an aerial survey* (Cambridge, 2nd edn, 1979), 271-2.

South of the "Roman Sea Bank", the Fenland was an inhospitable area of fens, meres, marshes and drainage channels until the early 17th century, with occasional "islands" where the pre-Quaternary rocks or glacial deposits projected above the Holocene deposits described in the last section. The people of the region lived from their freshwater aquatic environment - fish, eels, reeds and peat (there are no equivalents of the Norfolk Broads in the Fens, but evidence of late mediaeval turbaries shows in aerial photographs (Figure E); these exported peat for fuel to London). Fenland

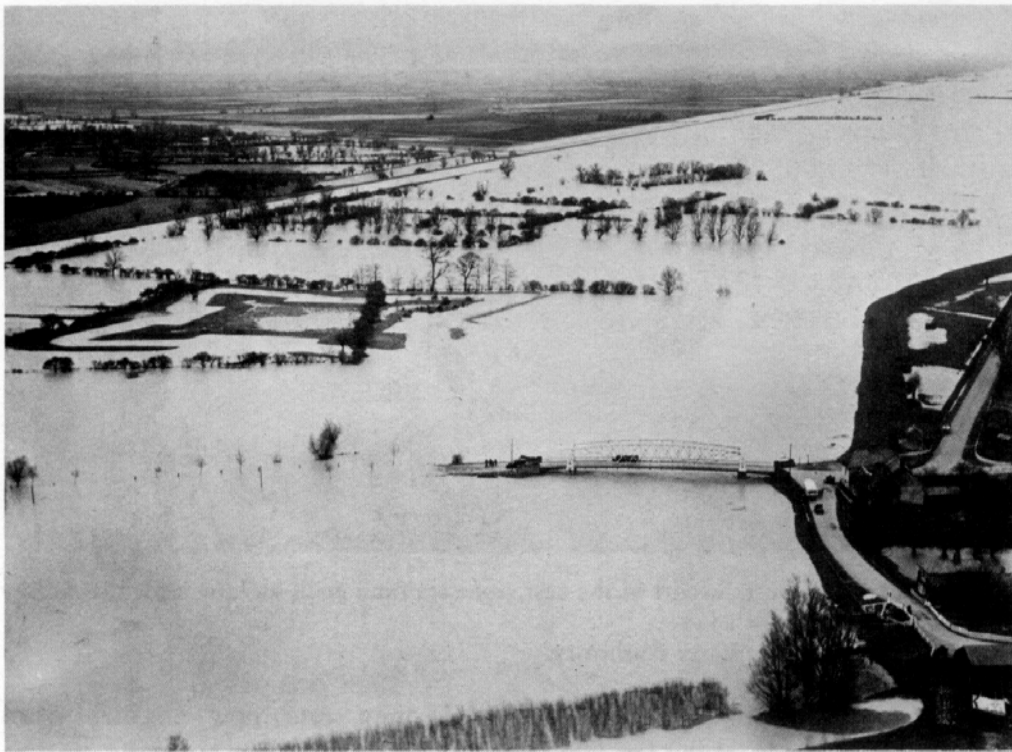
Figure F

Fig. 120 The flooded Washland, looking north at Earith, March 1937.
 Photo: Keystone Press Agency. Note the sharp line on the left which is the western boundary of the Washland (i.e. along the Old Bedford River). The bridge in the foreground crosses the New Bedford River, and the line of the road is marked by stakes and trees. The square pattern is an earthwork between the two rivers and shown up by the floods; it has nothing to do with the draining – V.C.H. *Hunts. I* (1926), 310.

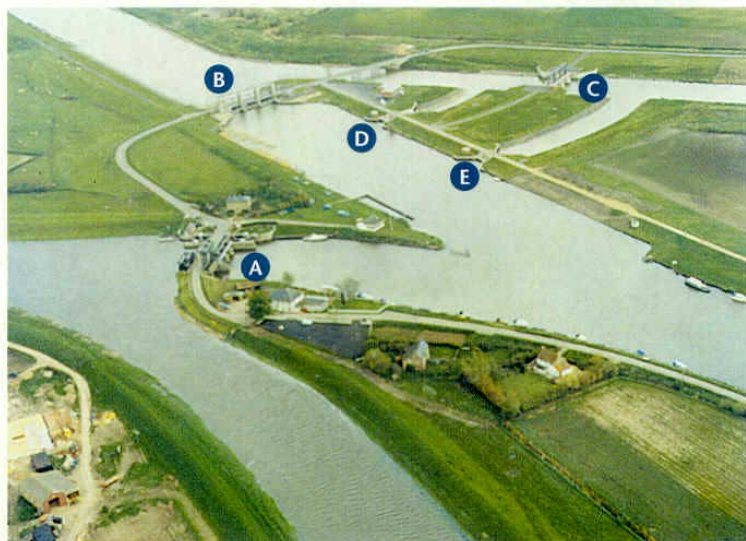
Figure H

DENVER CONTROL STRUCTURES

- A Denver Sluice
- B A.G. Wright Sluice
- C Impounding Sluice
- D Residual Flow Sluice
- E Diversion Sluice

And in 1964, the Cut Off and Relief Channel scheme was completed to discharge flood waters from the Lark, Little Ouse and Wissey (rivers draining into the Eastern Fens from the Chalk escarpment) directly into the Great Ouse near King’s Lynn, bypassing Denver Sluice (Figure H) at times when the Old Bedford River level below Denver is higher than the Great Ouse level above it. The Cut Off Channel can also be used in the reverse direction, to feed the Ouse-Essex water transfer scheme (Environment Agency, n.d.).

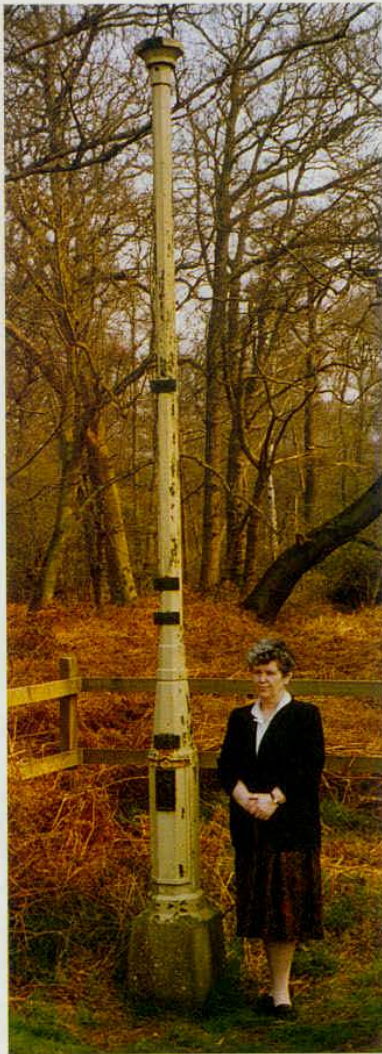
Figure I

The Holme Fen Post. A cast iron pillar, from the Crystal Palace Exhibition was erected in 1851 on the south west edge of Whittlesey Mere. It replaced the wooden posts which had been erected in 1848 to indicate peat shrinkage caused by drainage. The post was driven 6.7m through the peat into buttery clay until its top was flush with the ground. Within 10 years the ground level had fallen nearly 1.5m through shrinkage. A second post was erected in 1957 with its top at the same level as that of the original post. Plaques fixed to this post show the ground level at various succeeding dates. As one stands by the pillar now, on peat which actually quivers underfoot, it is difficult to realise that men who watched the last of the mere 120 years ago stood level with its top which is over 4m above today's ground level.

The lowering of the peat surface has been recorded on the Holme Post in Whittlesey Fen (Figure I). This was a cast iron pillar from the 1851 Crystal Palace exhibition, driven 6.7m into the clay beneath the peat. Within 10 years, the peat level had shrunk by 1.5m (Hutchinson, 1980), and today about 4m of the post stands above ground level - a rate of lowering of about 2.5 cm a year. Because of this shrinkage and lowering, buildings in the peat Fen often display evidence of subsidence, and roads are often uneven (Figure J). Furthermore, this shrinkage has accentuated the elevation difference between the drained land and the main, embanked rivers, and has necessitated pumping of water from the former, originally by many windmills (Figure K), then by steam engines (as that at Sutton), and latterly by diesel and electric pumps. It is ironic that there is now a highly-contested scheme to build wind-power generating capacity in a landscape which was once littered with windmills (Figure K)!

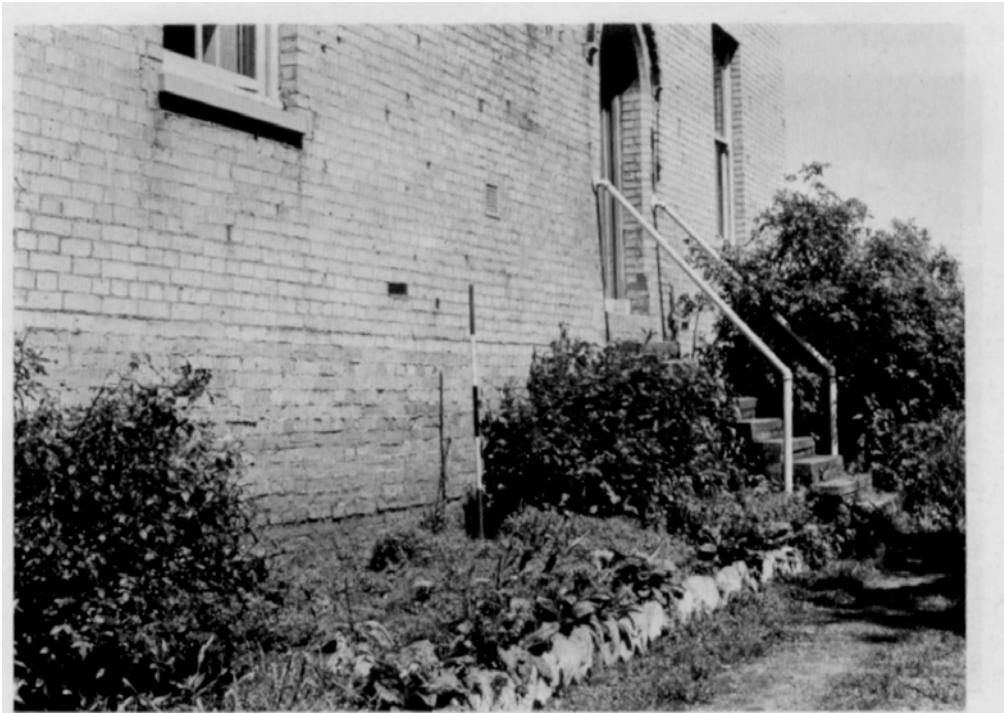
Figure J

Fig. 112 Lowered peat surface at the old vicarage in Prickwillow, near Ely, circa 1980. Photo: Anglian Water Authority. E. R. Kelly (ed.), *The Post Office Directory of Cambridgeshire* (London, 1879), 94-5 says that 'a commodious vicarage is in course of erection'. We may therefore ascribe the building to 1878-79, and it is marked on the O.S. 25 inch to one mile map of 1888 (surveyed in 1885). The brickwork was supported by beams laid on stilts driven through the peat into the clay beneath. At that time were two steps up to the front door. Since then another nine have been added from time to time as the surface of the surrounding land has become lower. The lowering has also resulted in a cavity beneath the ground floor of the house. I am indebted to the present owner of the house, Mr John Morley, for allowing me to inspect the lowering.

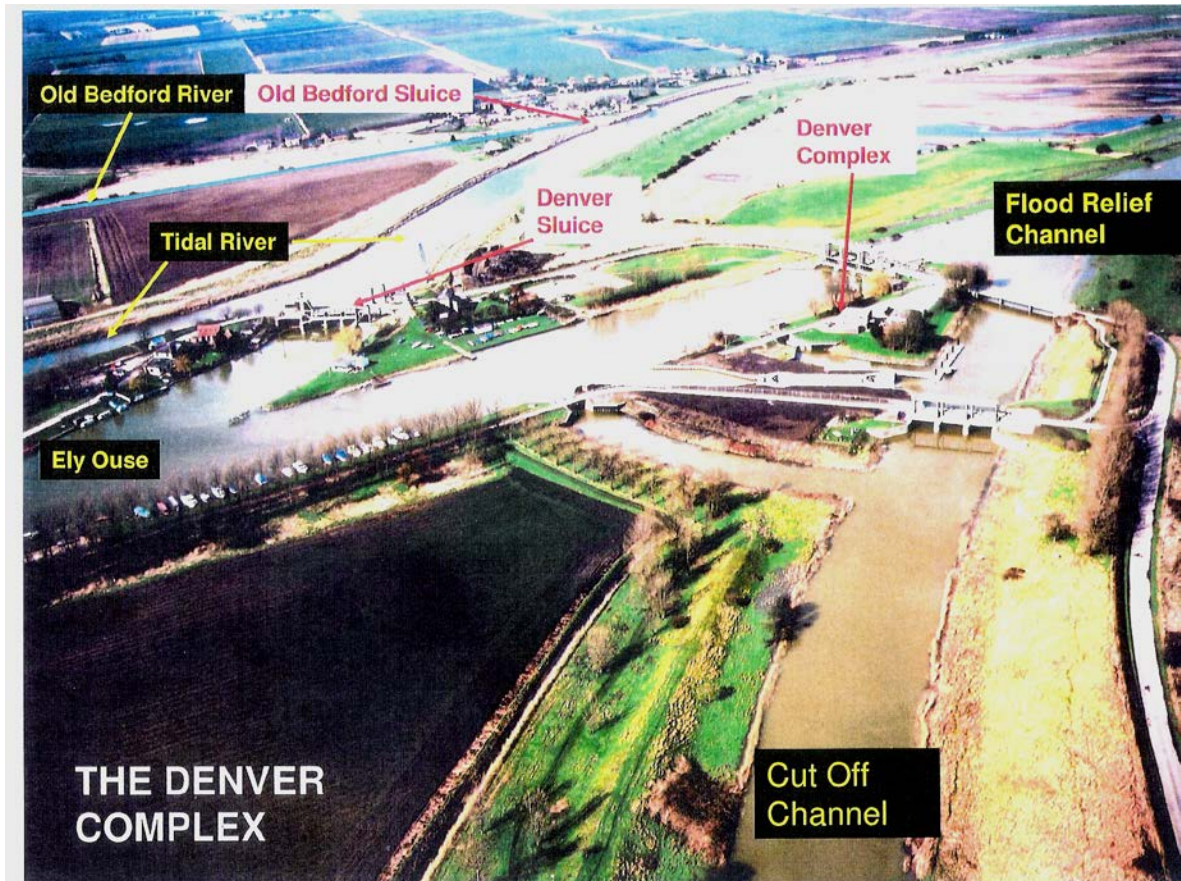
APPENDIX 1 - THE DENVER COMPLEX

- Maximise Discharge through Denver Sluice
- Evacuate water from Ouse Washes (1 April)
- Retain Ely Ouse Level (measured at Ely) at 101.6m Summer & 101.5 Winter
- Anticipate flood flow and manage the system to minimise the risk of flooding
- Maintain Old Bedford River level via gravity discharge through Old Bedford Sluice
- Manage Flood Flows from Cut Off Channel
- Manage the Ely Ouse Essex Transfer

The essence of Vermuyden’s and later drainage works was to shorten the routes of channels and evacuate excess runoff more rapidly to the sea. In 1637, Vermuyden constructed the Old Bedford River from Earith to Salters Lode (Figure 3). This was 21m wide and 34km long, with a sluice at Earith to regulate flow in the river’s original course, and at the lower end to prevent tidal inflow. The city and university of Cambridge petitioned against the downstream sluice in 1696, on the grounds that it impeded navigation and trade from King’s Lynn. The Old Bedford River was supplemented by the parallel New Bedford River (the “Hundredfoot River”) in 1651, with a washland between to take winter flood water. Today, this area - the Ouse Washes - is a Ramsar wetland reserve (<http://www.ramsar.org>), with an important migratory bird population (Figure F), and this has introduced some conflict between the flood management and conservation functions of the Washes. The downstream sluice was destroyed by floods in 1713, and tides again flowed into the southern rivers, until it was rebuilt as the Denver sluice in 1750, which was then rebuilt in 1834, 1923 and 1984. Figure 4 shows how the whole system of channels and the Washes interrelate, and the connections between the sluices at Earith and at Denver. The flows in the Fenland are today managed through the manipulation of the series of sluices at the Denver complex, which is illustrated in detail in maps and diagrams in Appendix 1.
